28 APR 1967

TECH. NOTE
M.E. 382

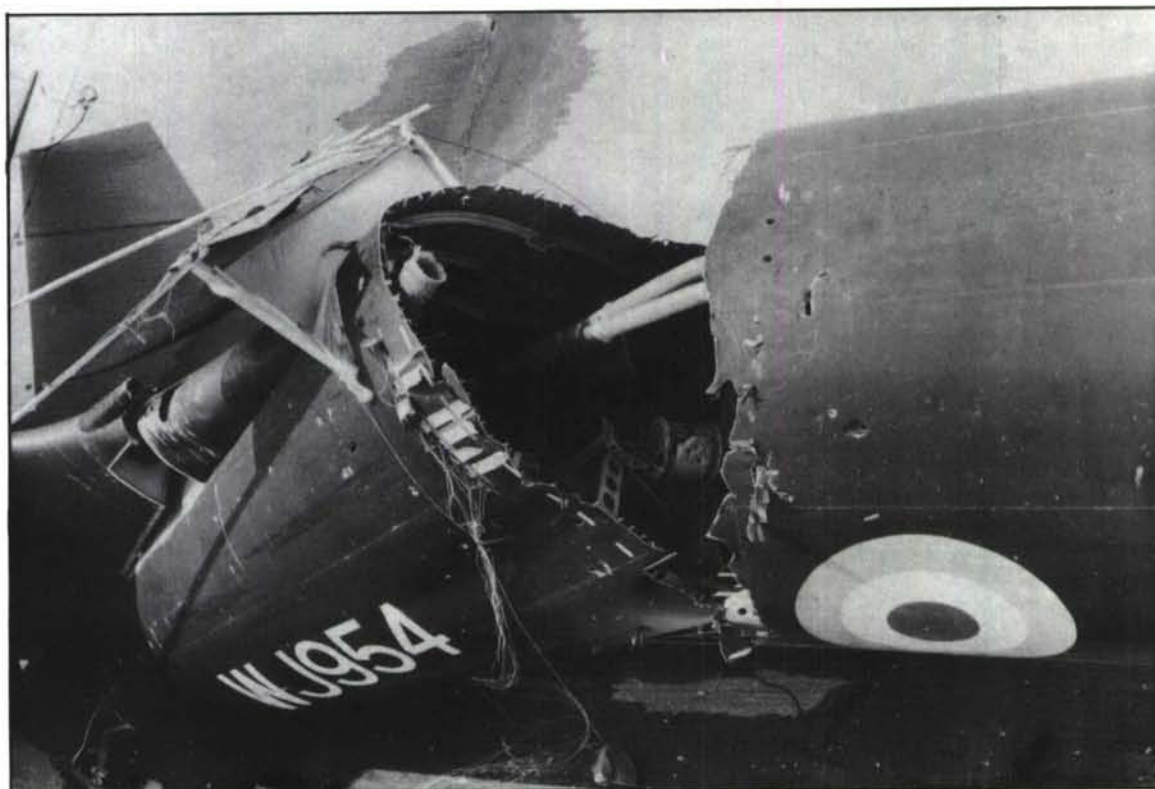
FIG.16b. TARGET 1a. DAMAGE TO ROD "ENTRY"
SIDE OF FUSELAGE SHOWING FAILURE

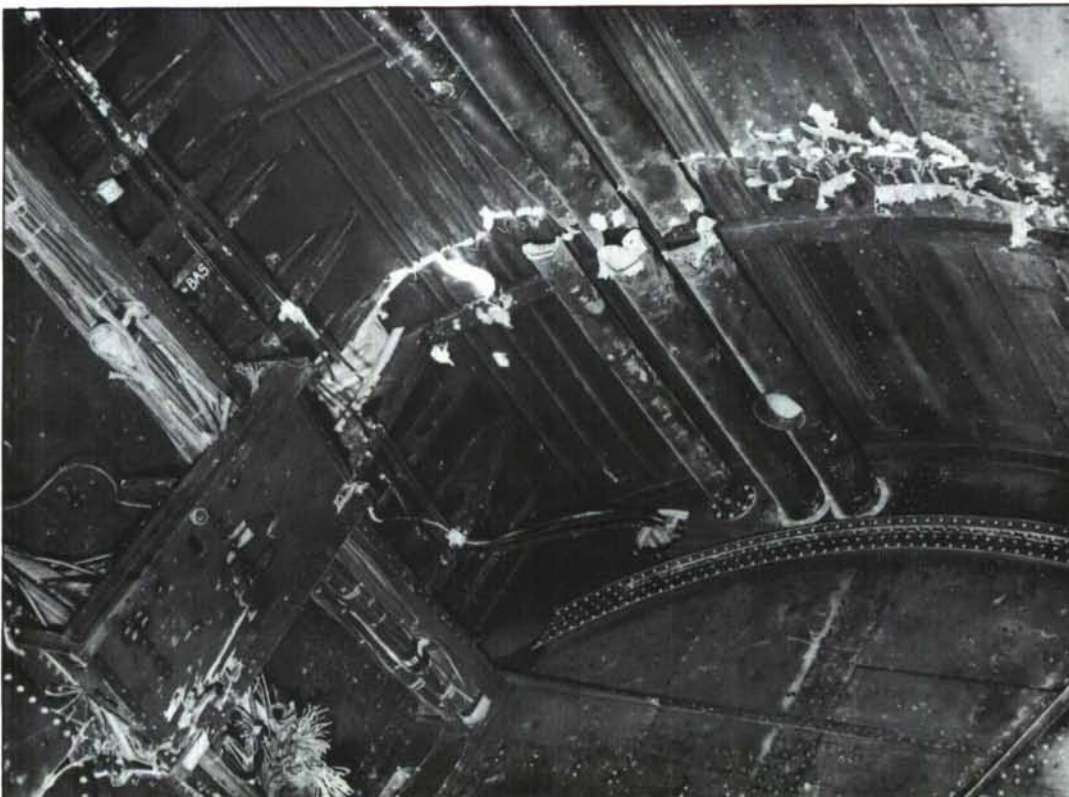
FIG.17e. ROD "ENTRY" SIDE

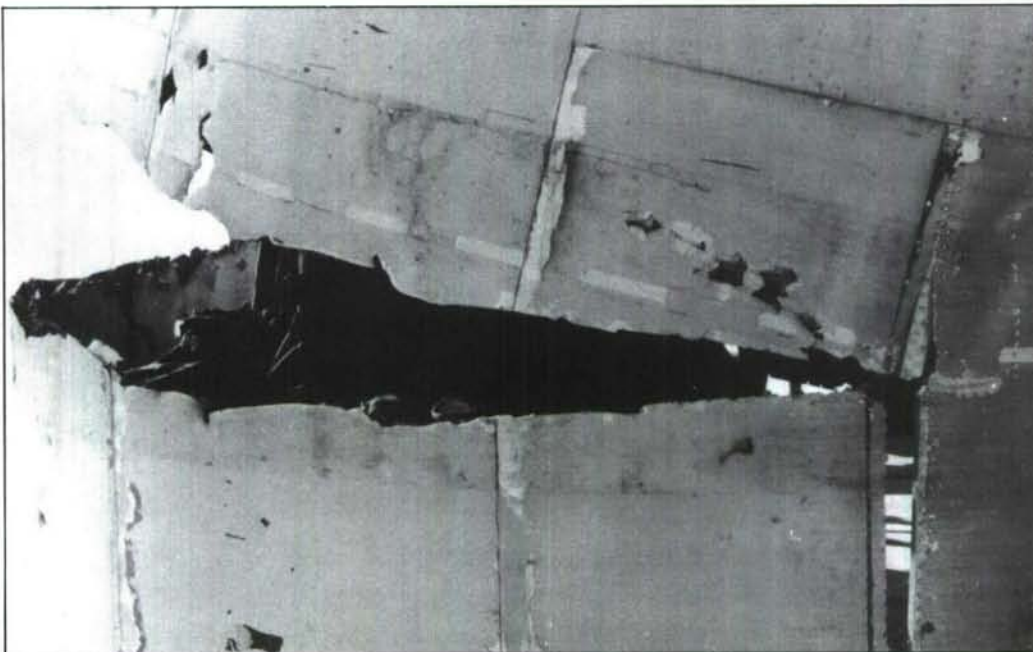
FIG.17j. ROD "ENTRY" SIDE

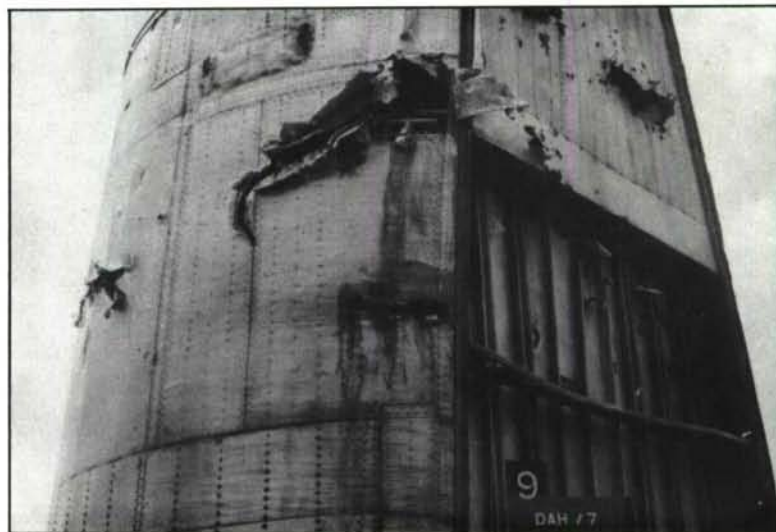
FIG.18c. ROD "EXIT" DAMAGE

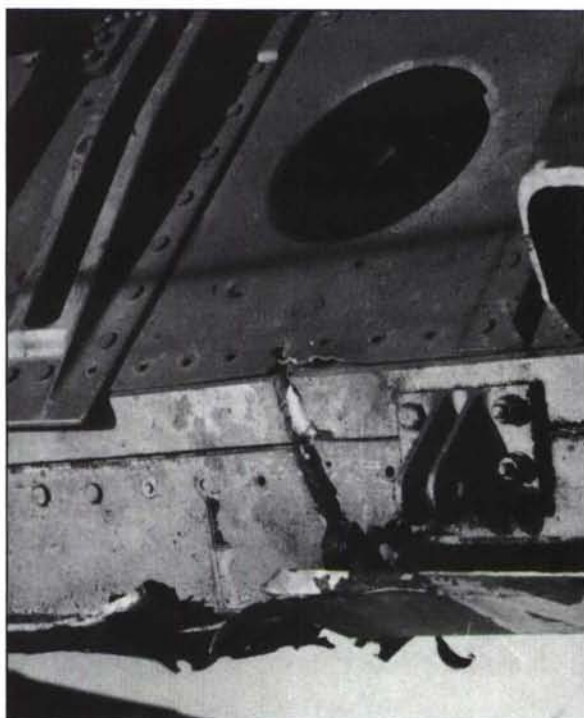
FIG.21e. STARBOARD LONGERON

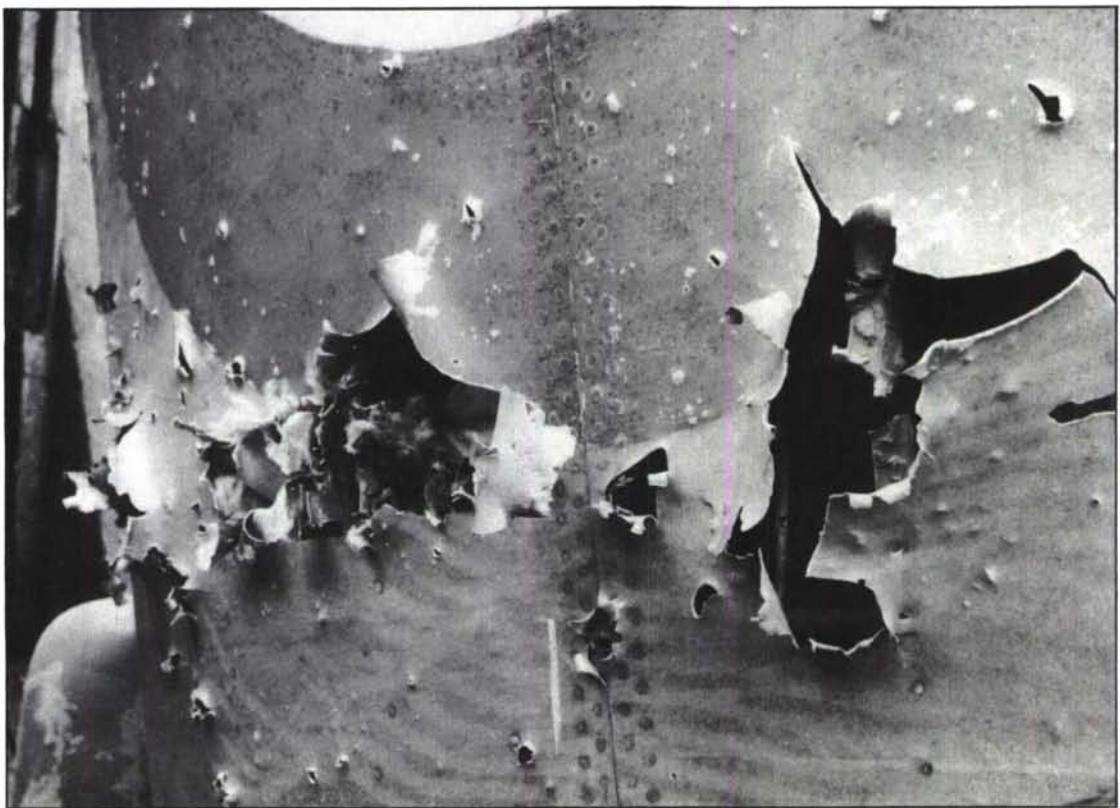
FIG.24d. TARGET 4a. DAMAGE TO ROD "EXIT" SIDE OF FUSELAGE
(HIGH VEL. $\frac{3}{16}$ in. ROD. STN. 768)

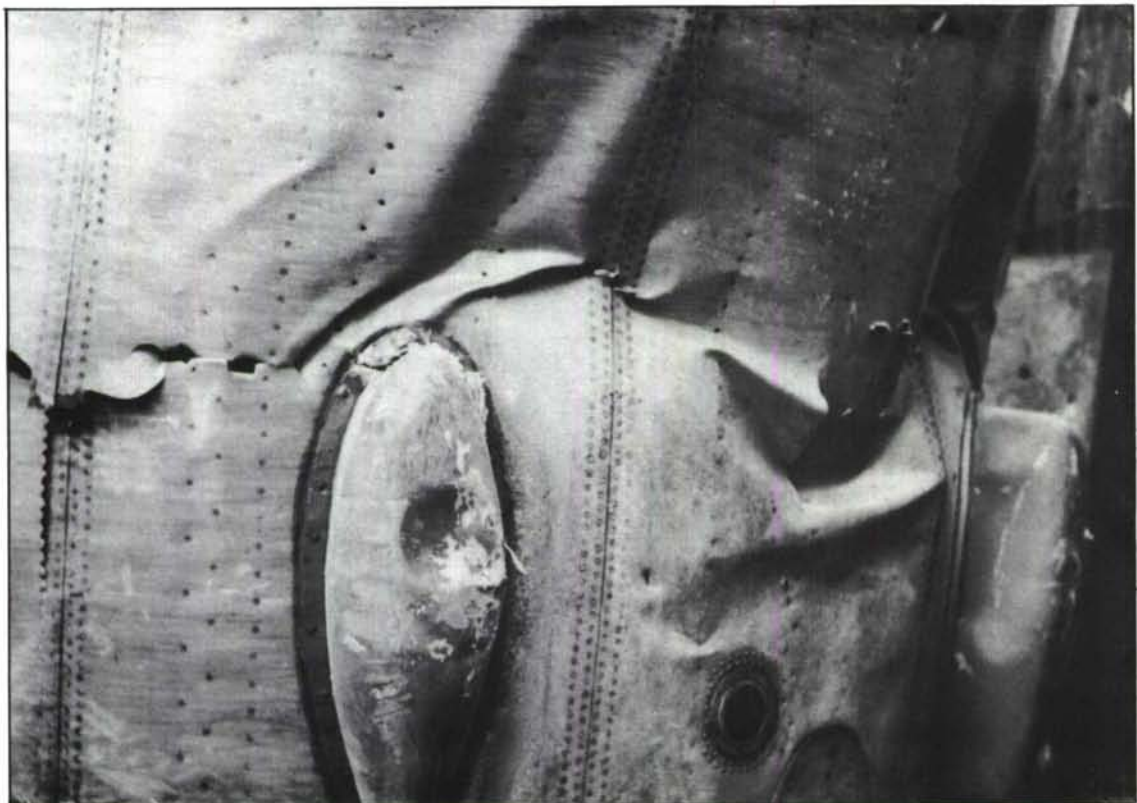
FIG.25d. TARGET 5a. DETAIL OF COMPRESSION LOADED SIDE OF FUSELAGE AFTER SUBSEQUENT FAILURE
(HIGH VEL. $\frac{3}{16}$ in. ROD. STN. 768)

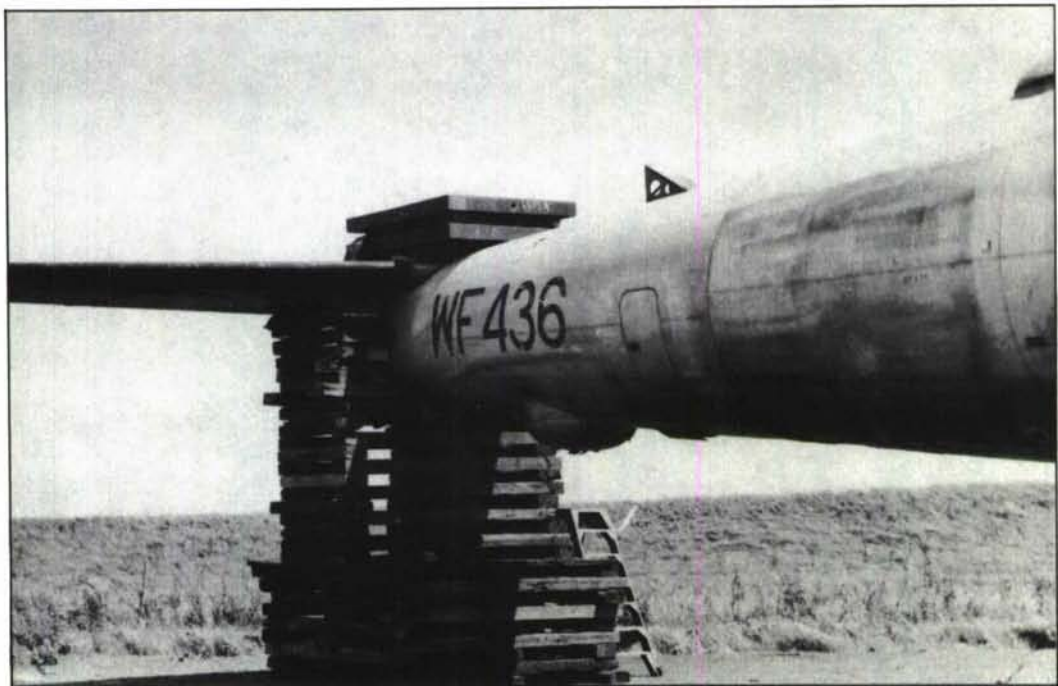
FIG.8b. OF APPENDIX I. DETAIL OF TAIL SUPPORT AND
COUNTERBALANCE LOADING
(TARGET 3b.)
